We were requested to conduct in-situ inspection, maintenance – and eventually – upgrade works on our customer’s 1700 DWT (1150 PAX) passenger vessel’s ME LO and LT FW Coolers.

**PROJECT SCOPE:** Various PHE in-situ Maintenance

**MAKE | MODEL:** APV R55, N35,  
**LOCATION:** Piraeus  
**VESSEL TYPE:** ROPAX Vessel  
**CAPACITY:** 1700 MTS (1150 PAX)

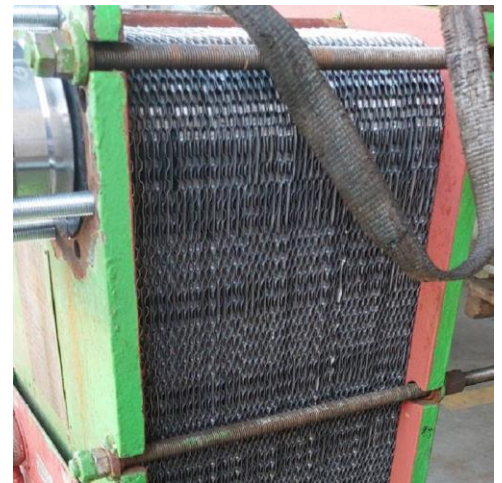
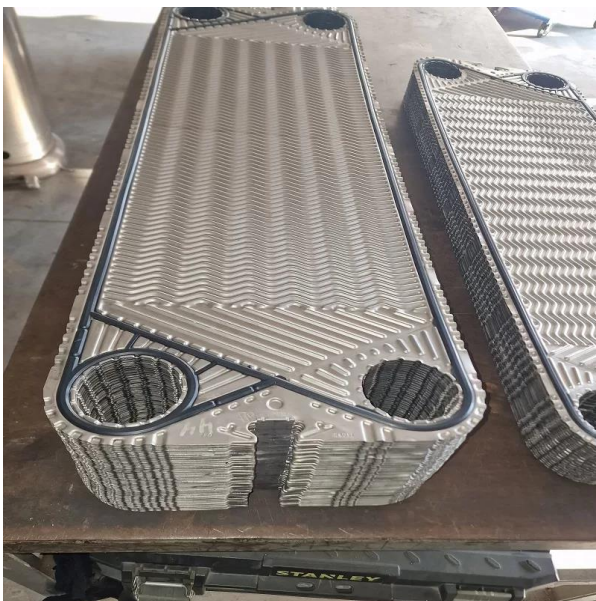
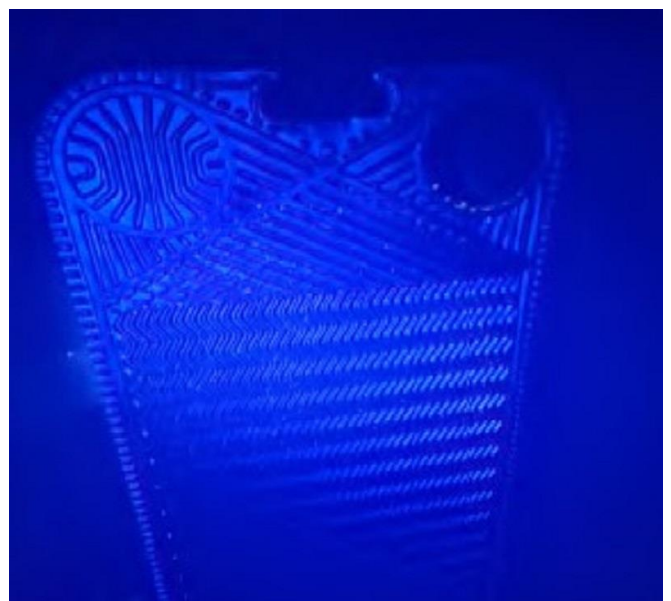
**ME LO Coolers findings:**

- Frame plate corroded at the SW inlet
- Groove deformations on several plates due to excessive tightening
- Wrong plate sequencing

**LT FW COOLERS findings:**

- Plate packs had been excessively compressed and the majority of plates were found heavily deformed
- Plate packs were found in poor condition, where the material aging was evident

**2** Maintenance & Repairs Stage:**ME LO COOLERS services:**

- Frame inlets were reconditioned and machined.
- Frame sets were epoxy painted.
- Pressure plates were upgraded with filter sets and flanges.
- All plates were checked, cleaned, repaired from deformations and re-gasketed.
- Units were hydrotested at both circuits. No leakages were detected.

**LT FW COOLERS services:**

- Frame sets were machined, reconditioned and epoxy painted.
- Pressure plates were upgraded with filter sets and flanges.
- Rubber sleeves and bolts were renewed.
- All plates were checked, cleaned, repaired from deformations and re-gasketed.
- Units were hydrotested at both circuits. No leakages were detected.
