PROJECT SCOPE: LT FW Maintenance

MAKE | MODEL: Sondex S187
LOCATION: Besiktas
VESSEL TYPE: Container vessel
CAPACITY: 5.500 TEU

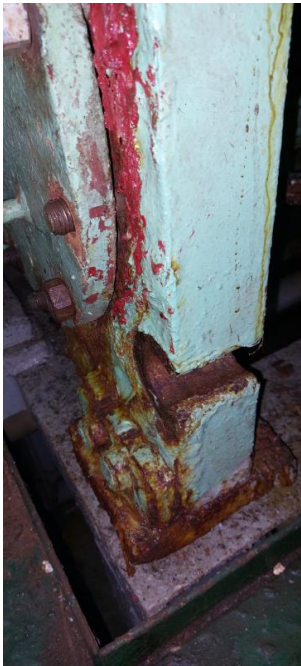
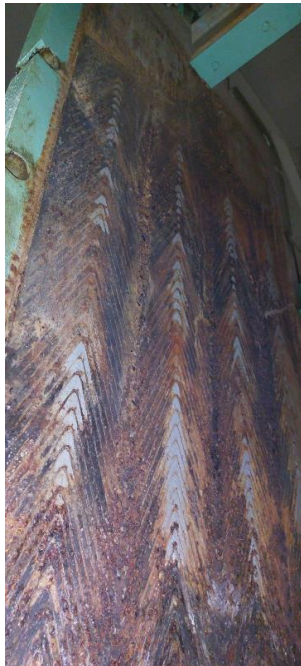
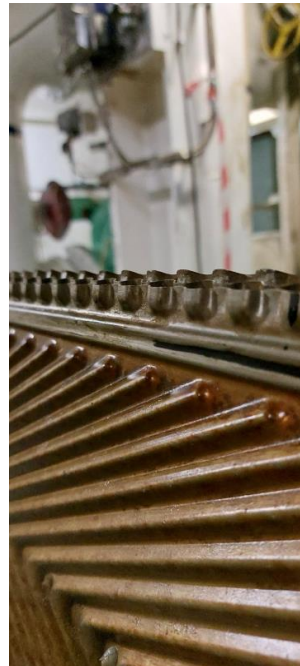
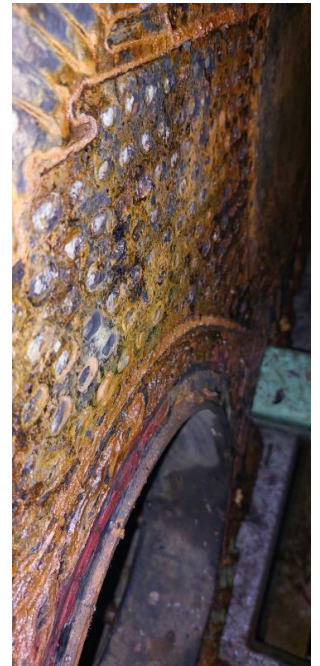
We were requested to perform an urgent maintenance service operation onboard our customers 5500 TEU lady berthed at Besiktas port, regarding one of her S187 LT FW Coolers. Our flying team of experts embarked the vessel, performed all necessary actions and proceeded with the inspection, cleaning, re-gasketing and replacement of the unit's plates. Furthermore, we discovered that the subject unit's frame set was heavily corroded, and subsequently moved forward with all necessary modification, installation and alignment actions. Upon all being set and done, we tested the unit and all leakage issues were successfully resolved. But this is not the conclusion of our story...

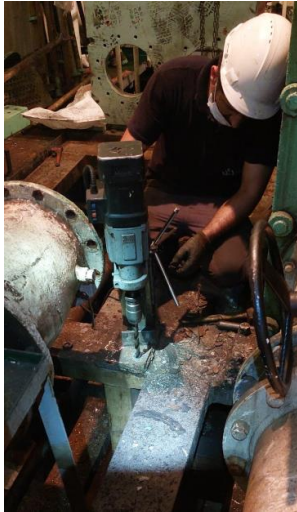
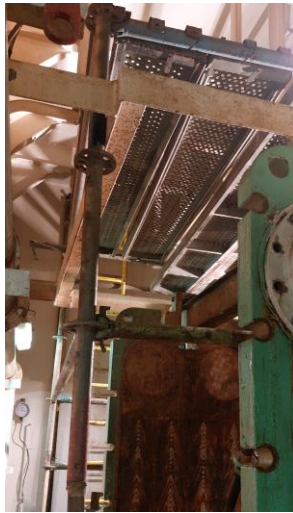
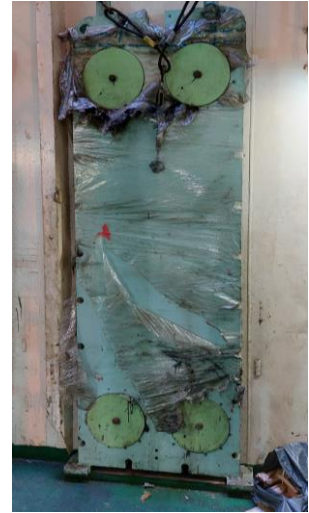
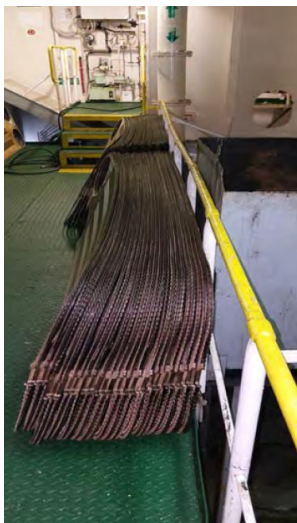
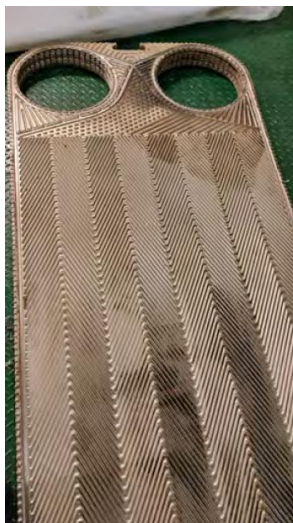
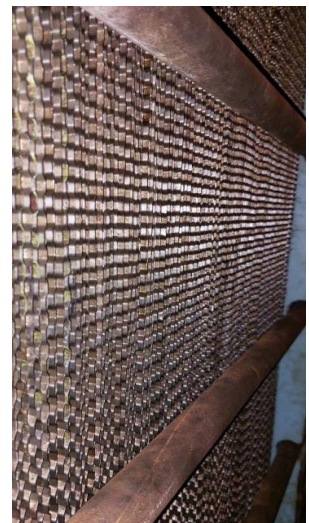
One of Maritech Group's core principles is being respectful towards our customers; act proactively, ensure their fleet's seamless operations and, by extension, their best interest. Our team preemptively inspected the remaining couple of LT FW coolers and adjacent existent issues were unfolded. The second unit needed cleaning and re-gasketing works, while the third one's status was diagnosed as "beyond repair", thus a replacement with a new plate pack was deemed necessary.

Our findings and recommendations were evaluated as crucial and additional service actions are required to be done, in order to safeguard this lady's seaworthiness.
